# **Milton Road, Bury**

## **Coal Mining Investigation and Geotechnical Assessment**

Job Number  
**LKC261326**

Report Date  
**30<sup>th</sup> September 2026**

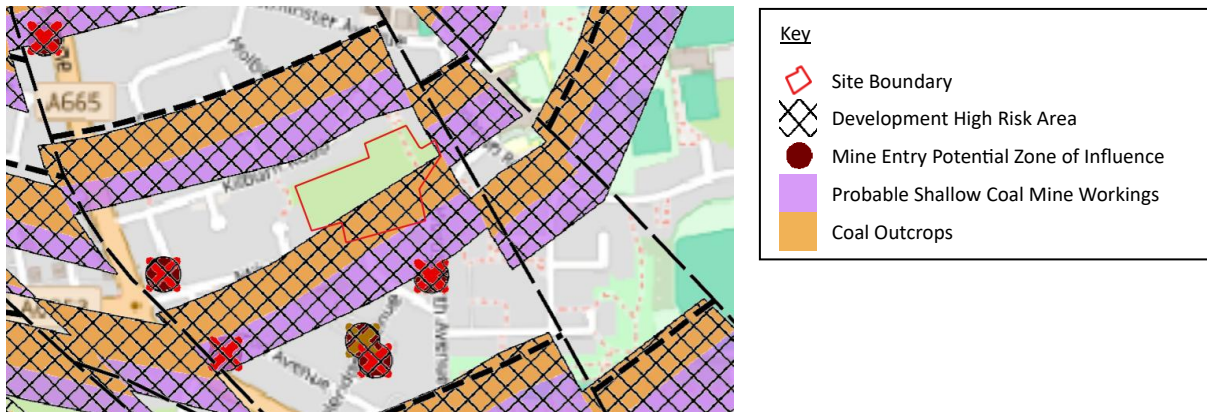
Plate 2-2: Development High Risk Area

The southern part of the site lies within a Development High Risk Area, shown as 'Probable Shallow Coal Mine Workings'. The remainder of the site lies outside the Development High Risk Area.

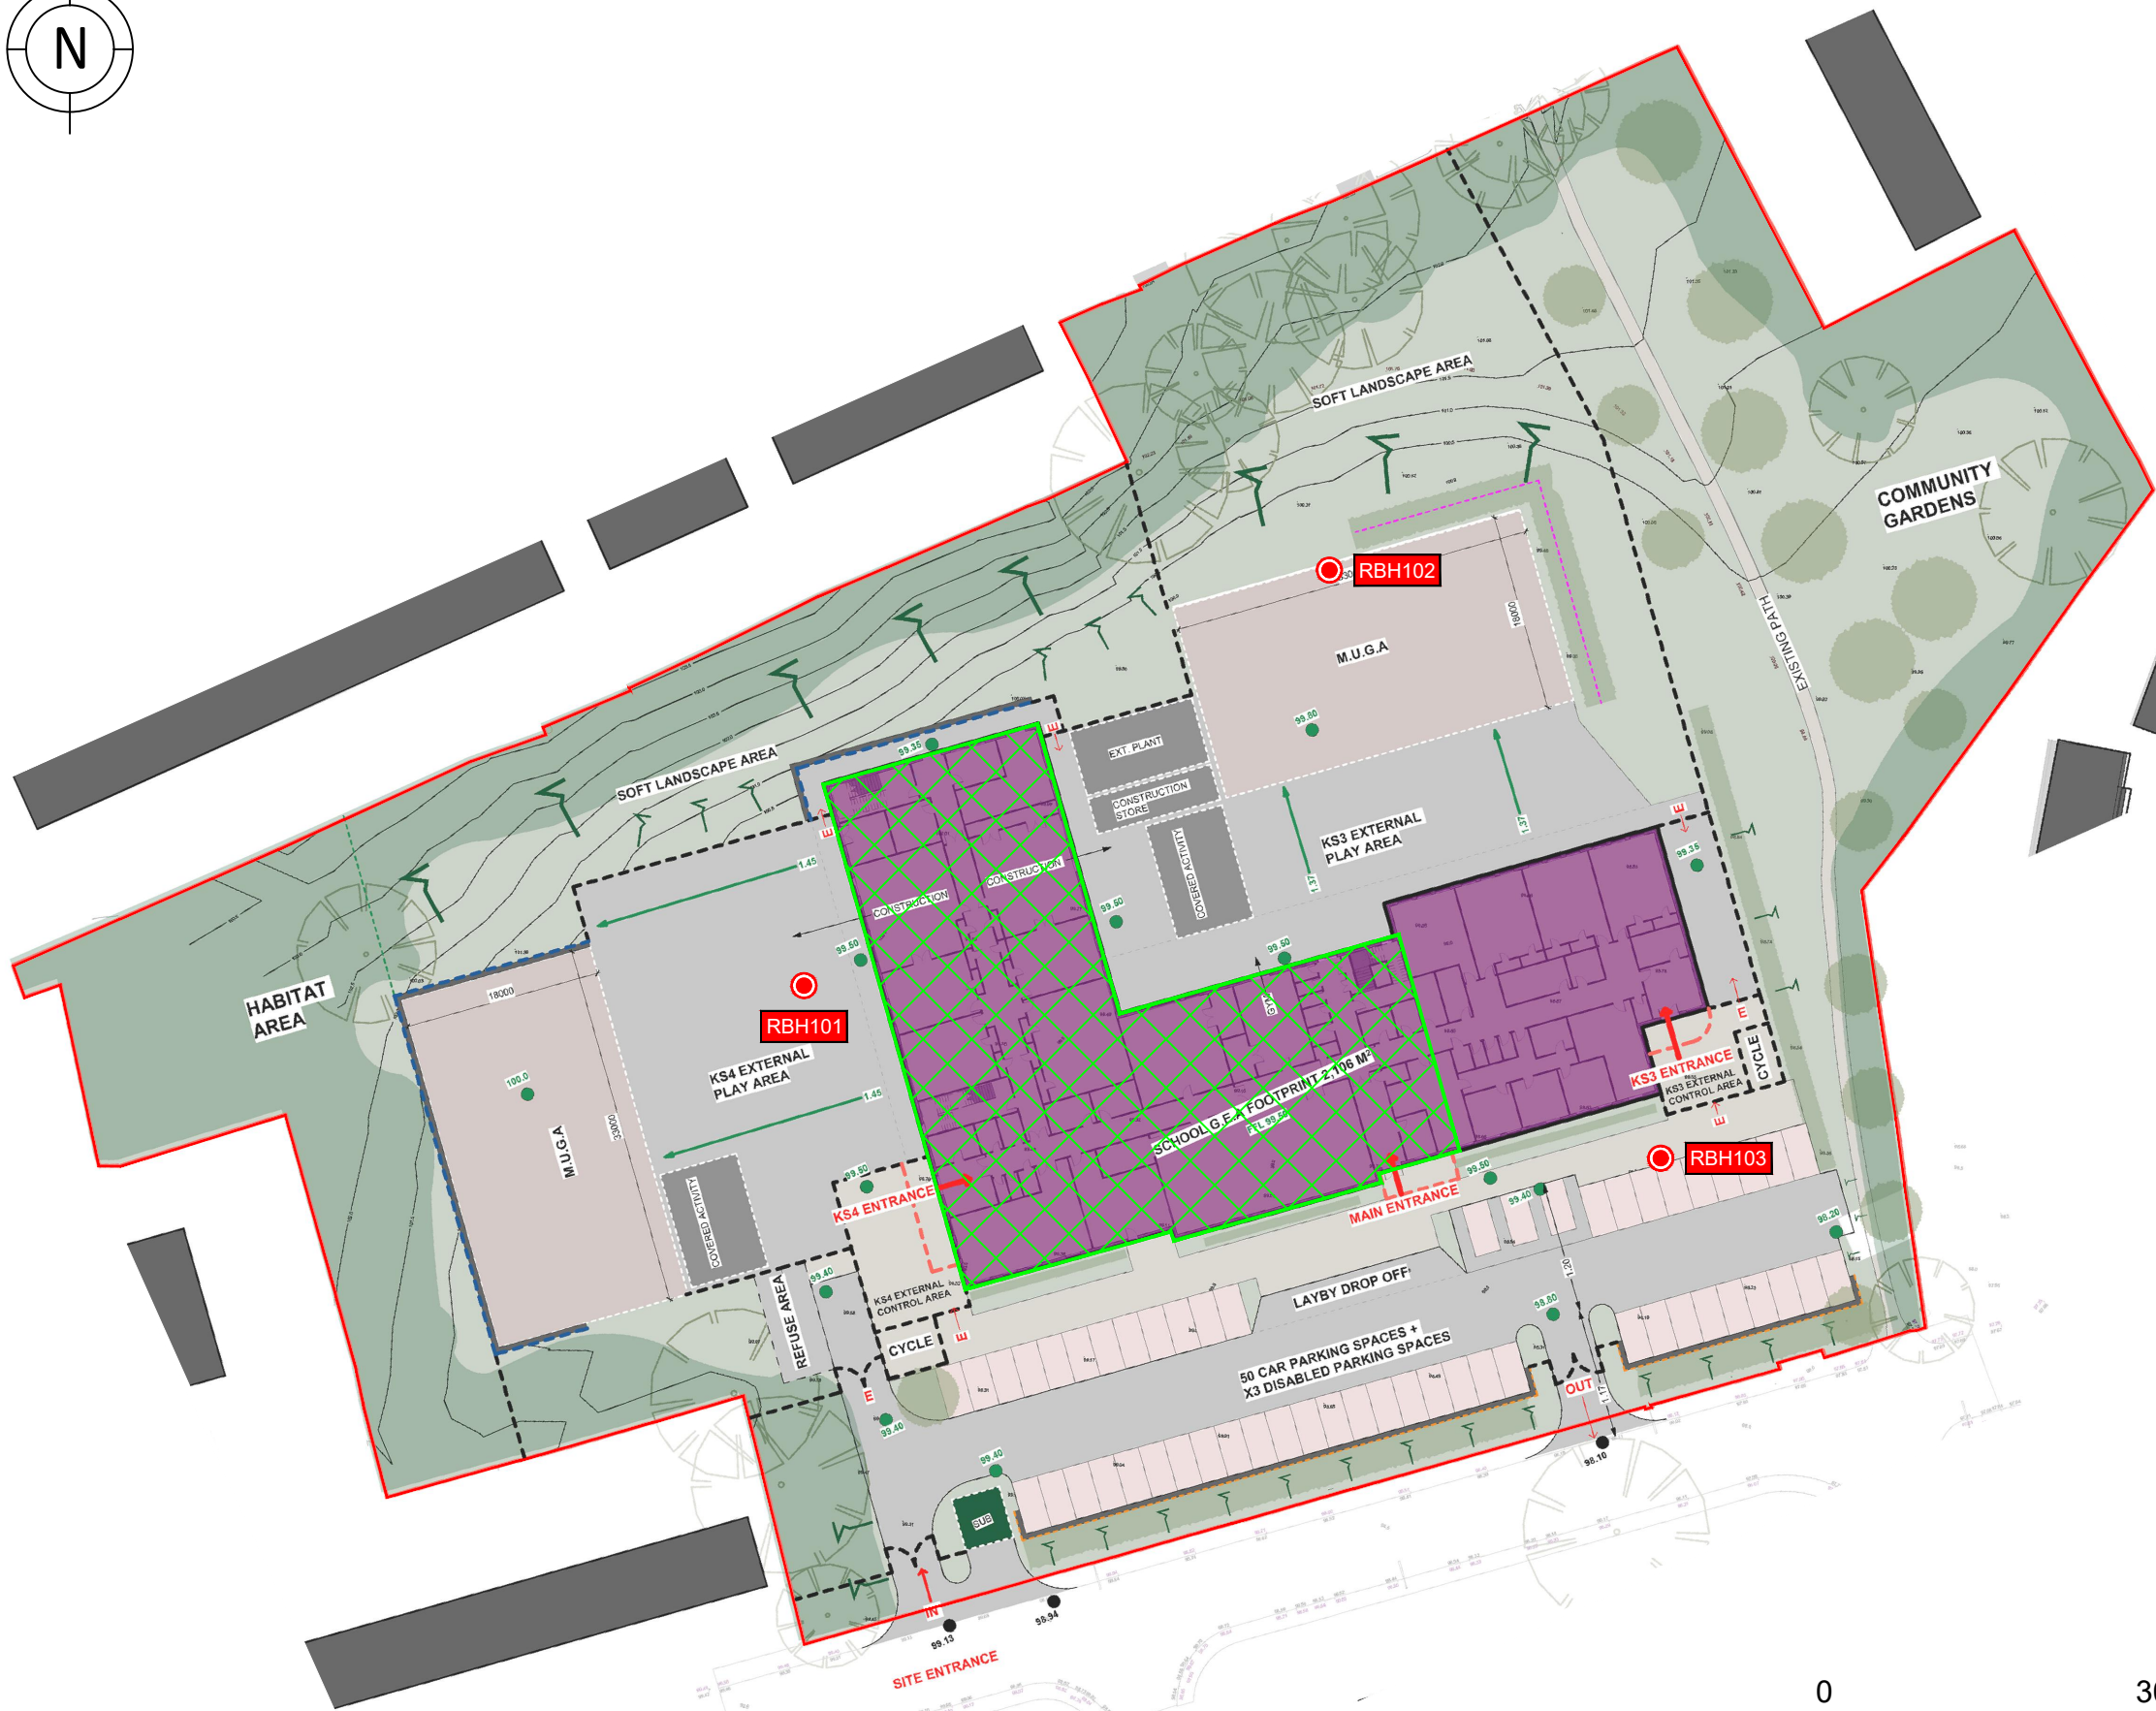
- Site Boundary
- Rotary Borehole (RB)
- Area Requiring Proof Drilling & Grouting

Based on the finding of the Coal Mining Investigation and Risk Assessment, a potential risk of ground instability associated with historical coal mining has been identified and stabilisation work is recommended as detailed below.
