## **GROUND INVESTIGATION REPORT**

**FOR  
LAND AT MILTON ROAD,  
RADCLIFFE,  
BURY,  
M26 3QY**

**PREPARED FOR  
BURY COUNCIL**

**REPORT NO. 8339A  
APRIL 2026**

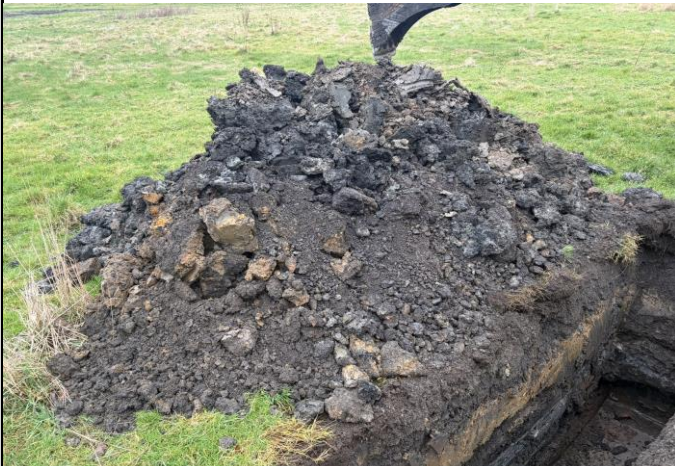
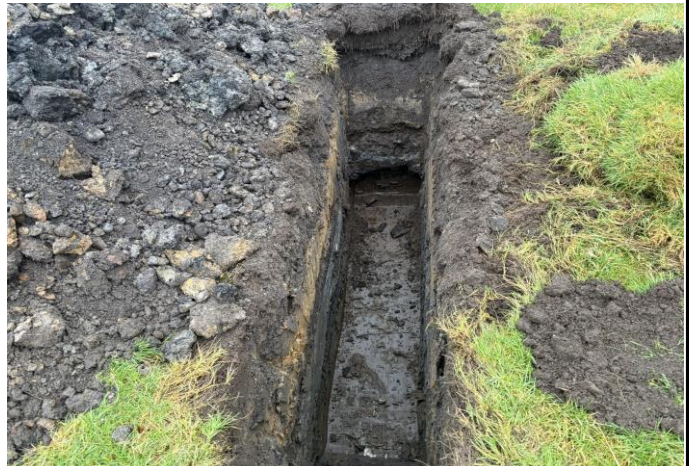
The results of the analyses undertaken to date suggest that the PAH contamination found in TP6 (including naphthalene which may produce vapours) may be contained within a localised hotspot. We recommend that further investigation of the affected area is undertaken to delineate the extent of the PAH contamination and to assess the significance of the elevated results. If the additional investigation confirms the PAH contamination is limited to a localised hotspot, this may be able to be excavated out and subjected to ex-situ treatment or disposal at a licensed waste disposal facility.

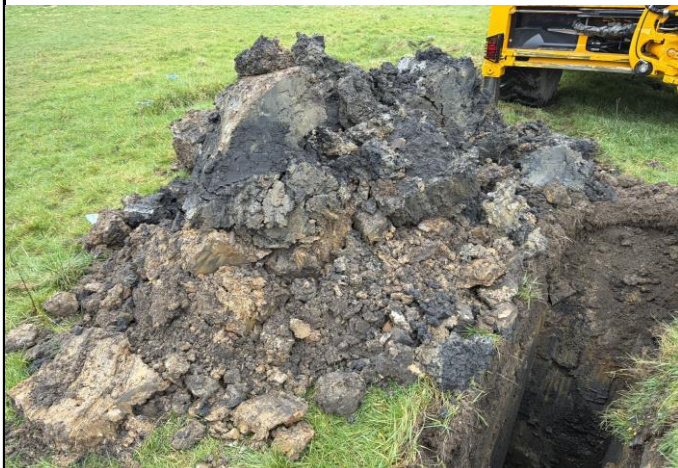
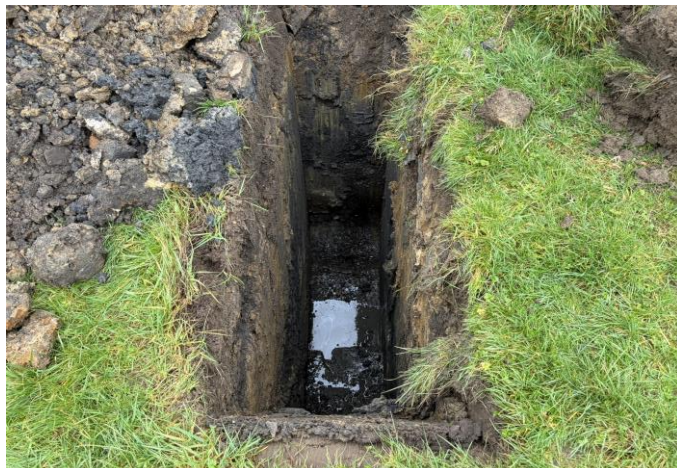
In the north eastern area of the site deep made ground was present in M5 to 2.65 metres, overlying soft to firm clays to 3.15 metres, and in TP7 made ground was present to 1.40 metres over very soft and soft silts (with an organic odour) and clays to 2.80 metres. In this area consideration may need to be given to piled foundations. The desk study indicated that ponds, brickworks excavations and associated ponded water was historically present in this area.

We would recommend that further investigation is carried out once a proposed development layout is determined, to enable a detailed assessment of foundation requirements to be made for each individual building or structure. Also the northern strip of the site should be investigated once suitable access is made.
