# Memo

**Subject** Wellington Road Landfill – Technical Review of Existing Information **From** Peter Kenny

## WELLINGTON ROAD LANDFILL SITE, BURY

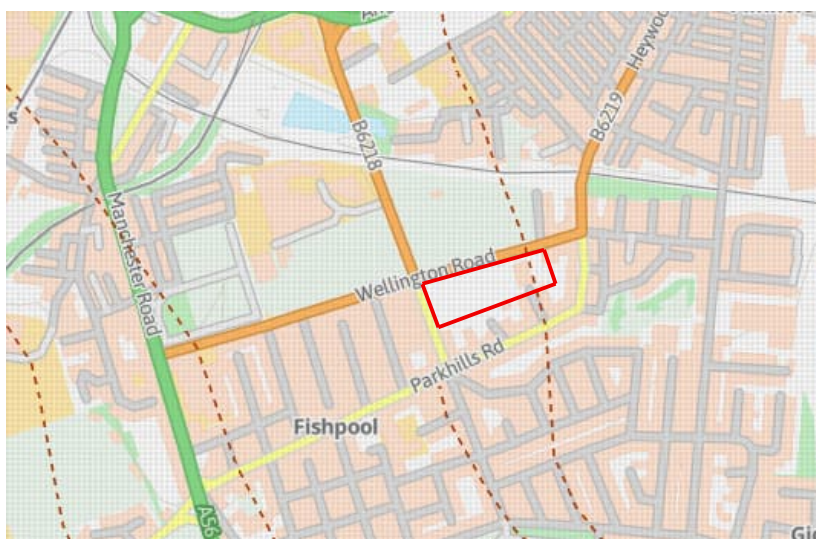
2.7 Although the exploratory hole locations from the SubS investigation cannot be accurately confirmed, the suggested locations of BH2 and BH4 from the included plan do generally correspond with the inferred location of the coal seam shown on the Mining Remediation Authority's interactive mapping, see insert below:

Figure 2.1 Mining Remediation Authority – Coal Seams

2.6 Where encountered, bedrock was recorded between approximately 30.75 ft (9.4m) and 45.25 ft (13.8m) depth. In BH2 and BH4 (note, from review of the logs, the report incorrectly refers to BH2 and BH5 in Section 3. g)), coal was recorded at the top of the bedrock and SubS noted that this may be associated with the Arley Coal Seam.
